DUNLAP SPILLGATE HINGE INSPECTION REPORT

BLACK & VEATCH PROJECT NO. 400368

Guadalupe-Blanco River Authority

13 AUGUST 2019

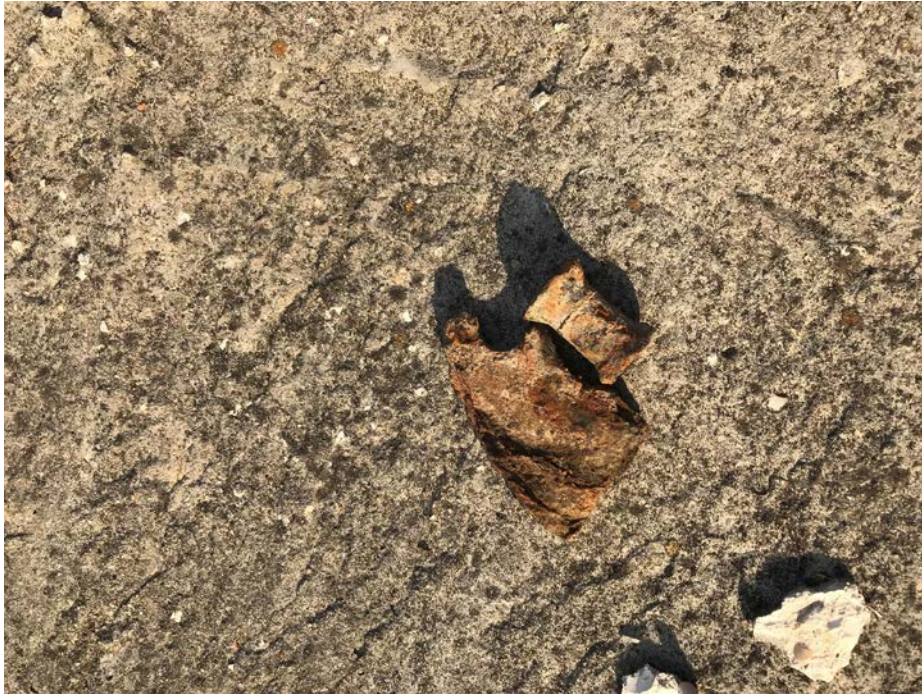
Figure 5-1 Hinge Plate retrieved from Gate No. 2

- All of the thirteen hinge casting pairs which are partly embedded in the concrete were found to be in place still anchored to the concrete. The hinge pins of all thirteen hinge assemblies were still in place and connected to the castings.
- The concrete structure to which the hinge castings are anchored was in fair condition with no severe damage observed.
- At all thirteen hinge locations the hinge plates previously connected to the hinge pins were missing. It is presumed the hinge plates were ripped from the hinge pins during failure of the gate. Small broken pieces of hinge plates were found at some hinge locations. The

portion of the hinge plates that were found were in poor condition with significant corrosion observed. Photos of the hinge plate pieces recovered during the inspections are included in Figure 5-1.

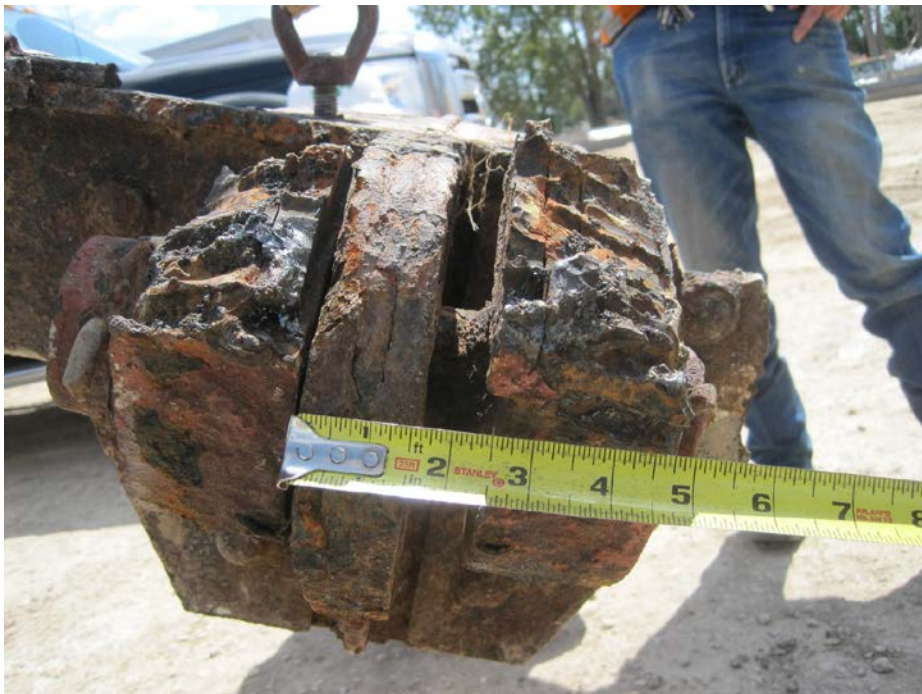
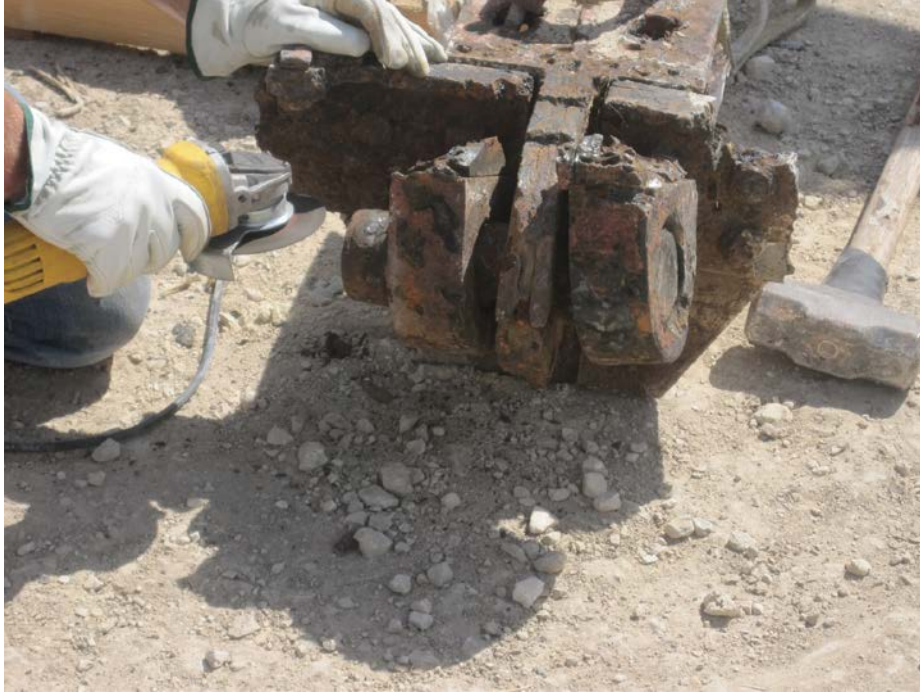
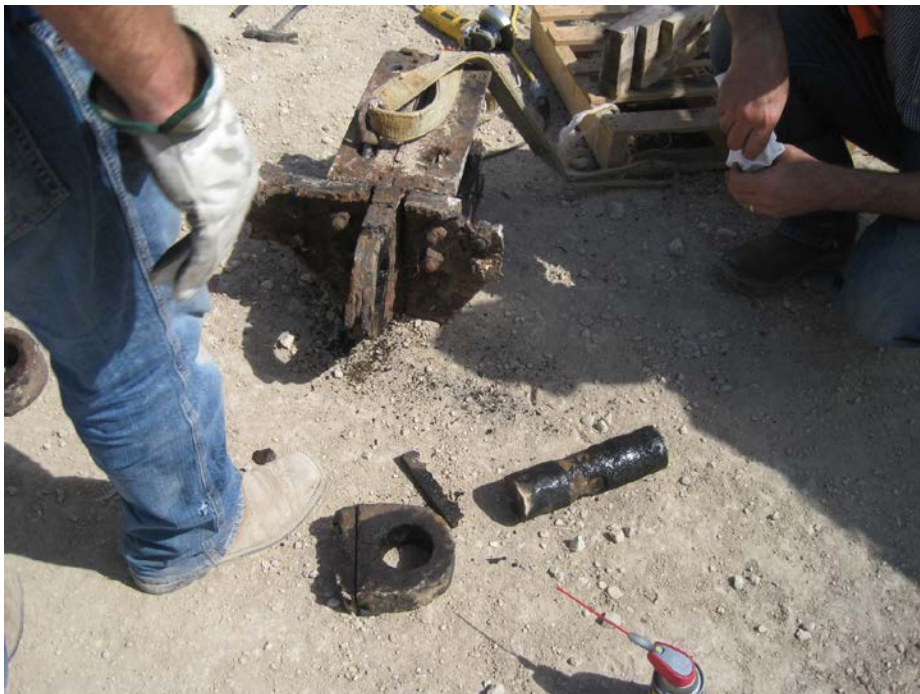
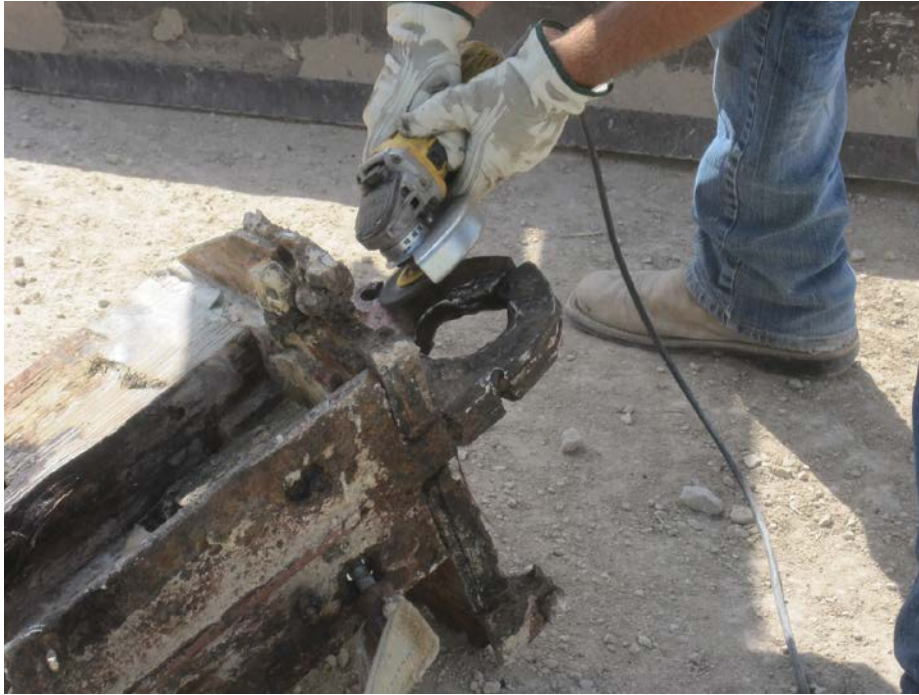
On August 7, 2019 one hinge assembly from Lake Dunlap Dam Gate No. 1 was removed from the gate and brought onto dry land for inspection. Removal of the hinge assembly was labor intensive; requiring almost 2 weeks for the diver and contractor teams to access the hinge assembly and then cut it from the gate. The design of the gates does not provide for removal or replacement of the hinge assemblies. The destructive removal of a hinge assembly prevents that gate from being put back into service without significant repairs to replace the hinge assembly. Once the hinge assembly was on dry land, it was disassembled and cleaned with a wire brush to visually inspect the three components of the assembly; the castings, the hinge plates, and the pin. See Figure 5-2 to Figure 5-5.

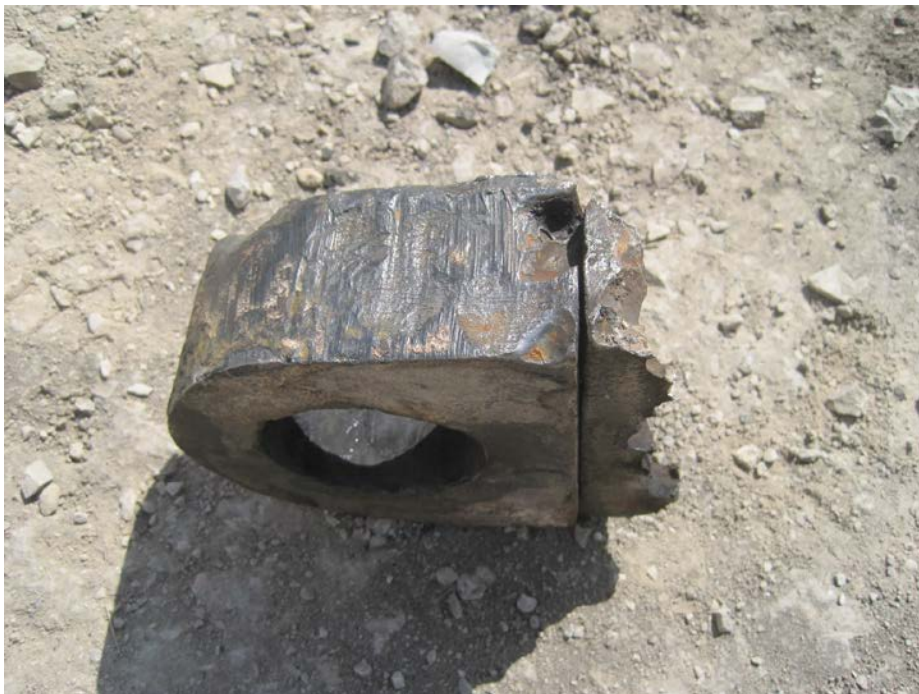
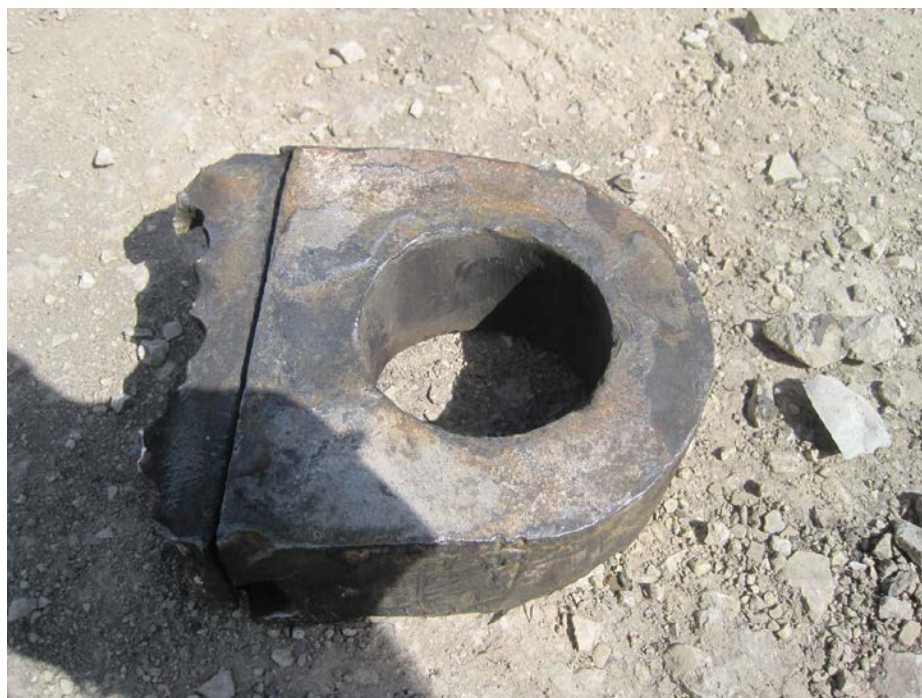
- The castings were found to be in fair condition with little sign of wear or corrosion. See Figure 5-6 and Figure 5-7.
- The hinge plates were found to be in poor condition. The hinge plates exhibit significant corrosion on the upstream side of the hinge plates with less corrosion on the downstream side of the hinge plates. The notch in the hinge plates for the pin shear key is still well defined on the downstream side of the connection whereas on the upstream side corrosion has eliminated any indication of the notch. See Figure 5-8 to Figure 5-15.

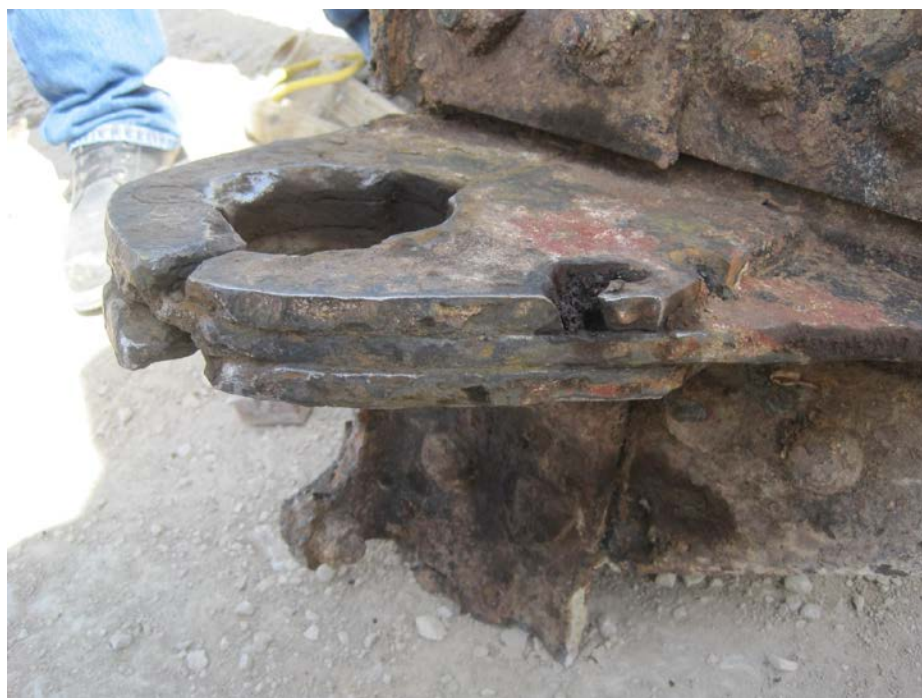
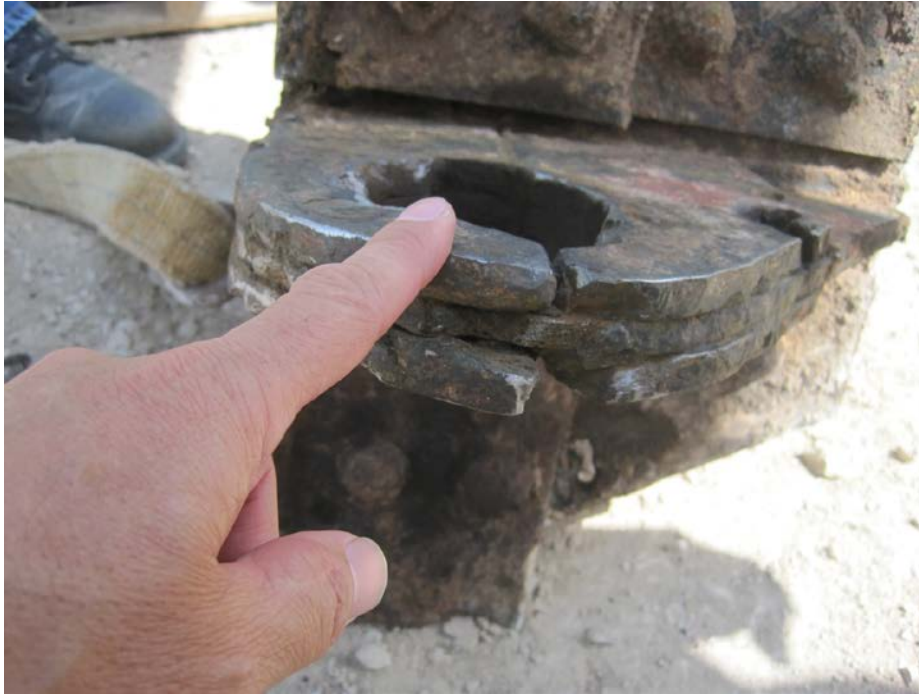
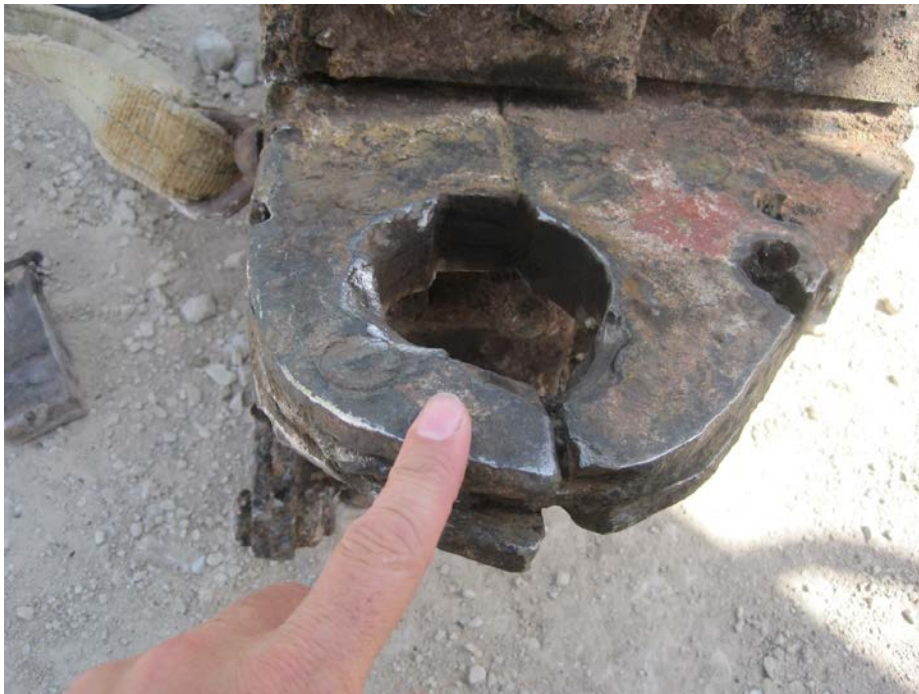
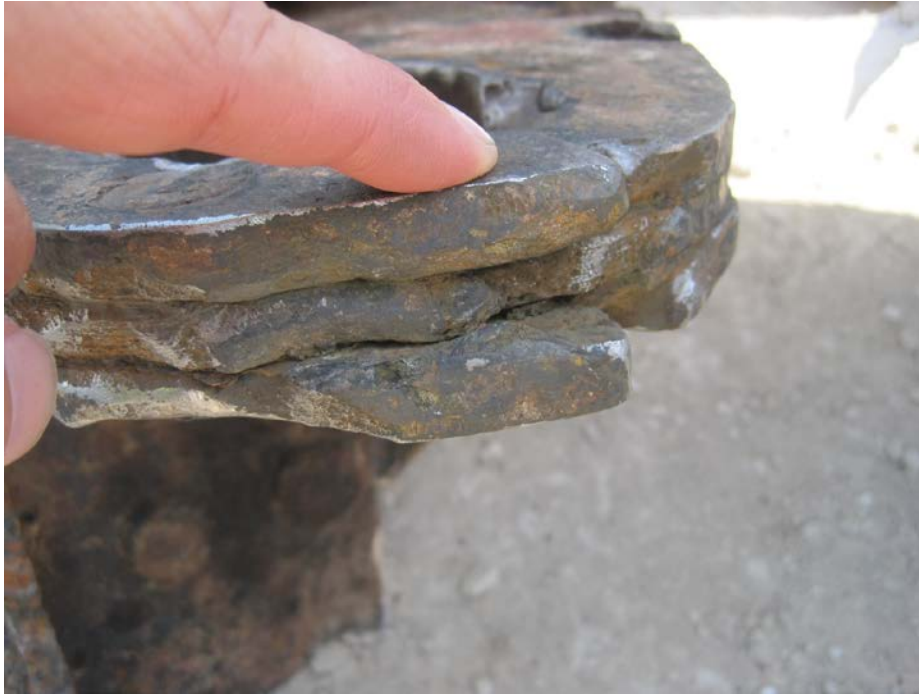
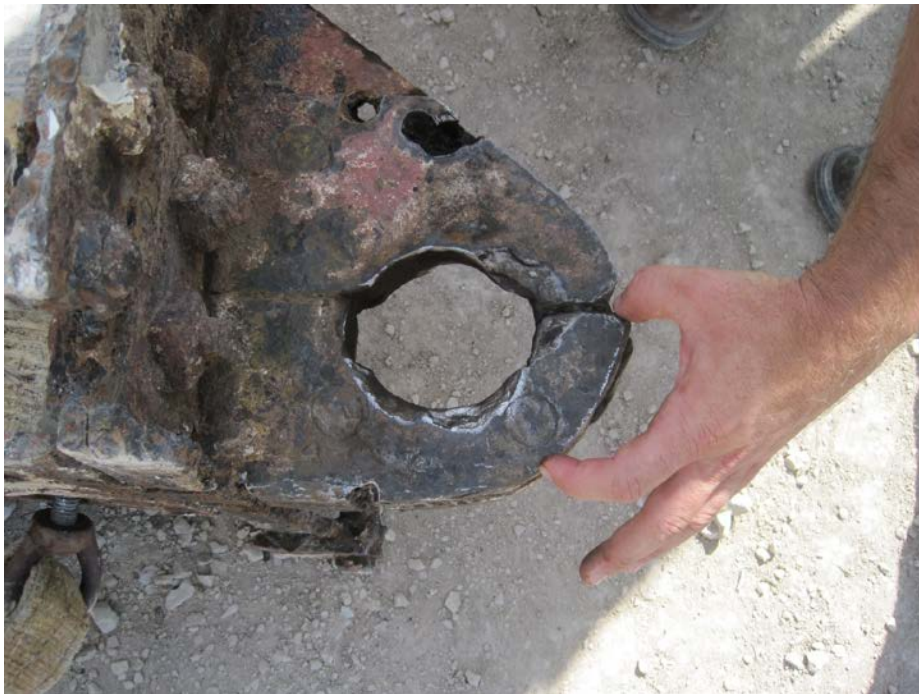
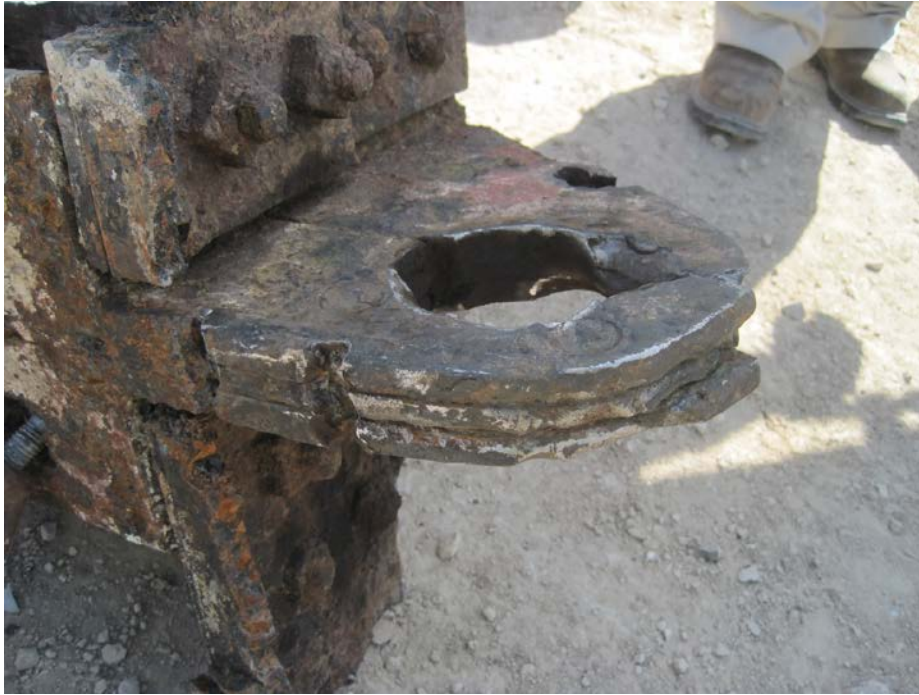
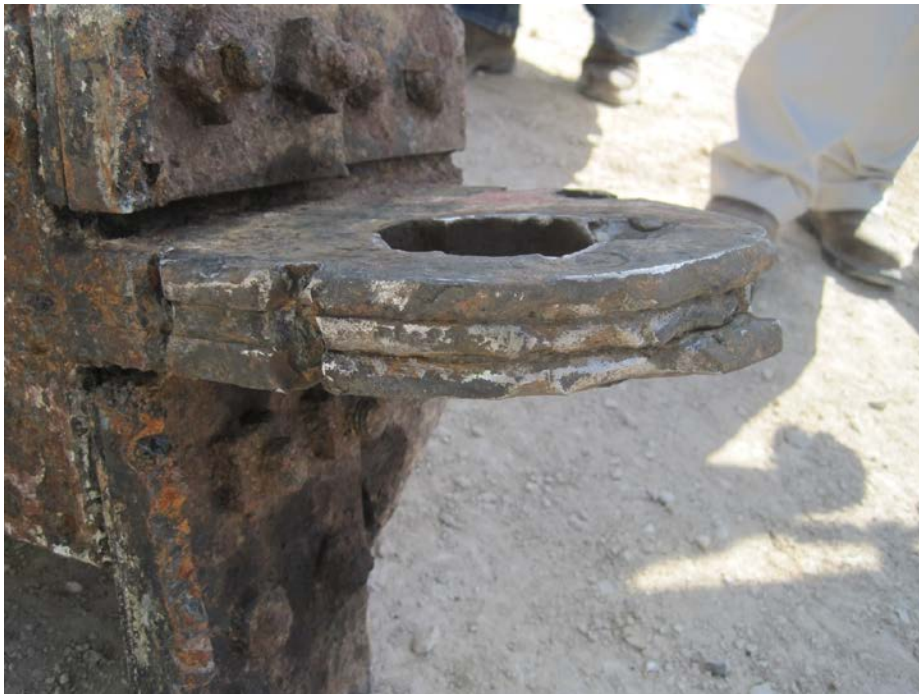
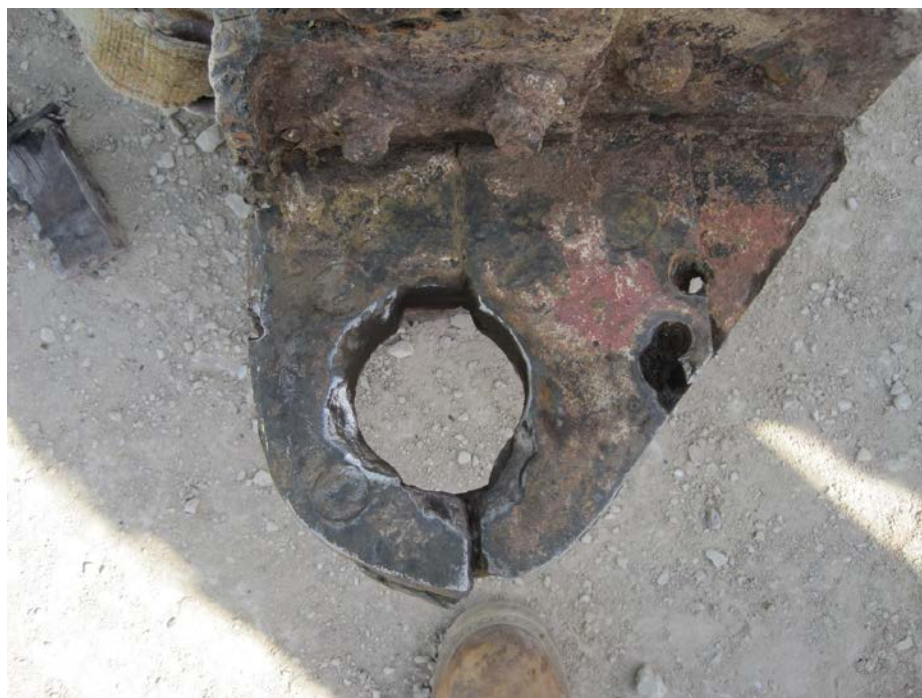
- The components of the inspected hinge assembly were no longer interacting with each other as intended. The hinge components were all still held together but no longer functioning as an engineered hinge. The design of the hinge includes two steel shear keys between the hinge plates and the pin. While there were visual indications that the hinge assembly had been constructed with the shear keys, the severe section loss on the pin and to a lesser extent the hinge plates showed that the shear keys had not been present for an extended period of time. The purpose of the shear keys is to prevent rotation of the pin within the hinge plates. By connecting the pin and the hinge plates, rotation is forced to occur between the pin and the castings. The surface areas in contact between the pin and the castings is much larger than the surface area in contact between the pin and the hinge plates. This larger surface area results in a much lower stress between the rotating parts and presumably less wear on the hinge assembly. What was found during inspection and disassembly of the hinge assembly is that because of severe section loss there was no longer a tight fit of the pin through the hinge plates but instead there were extreme gaps between the pin and hinge plates resulting in a loose and misaligned connection.

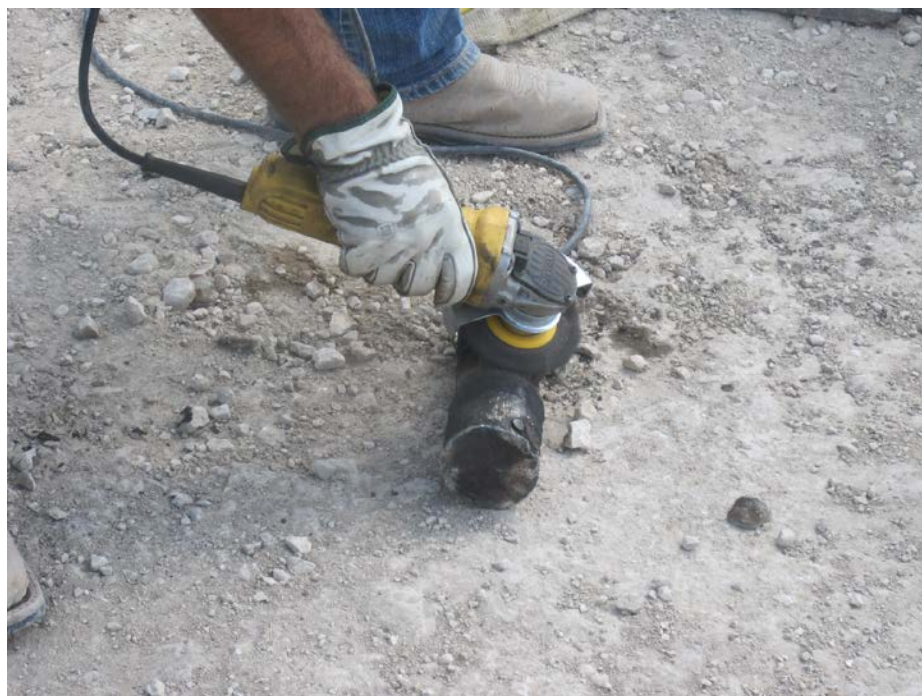
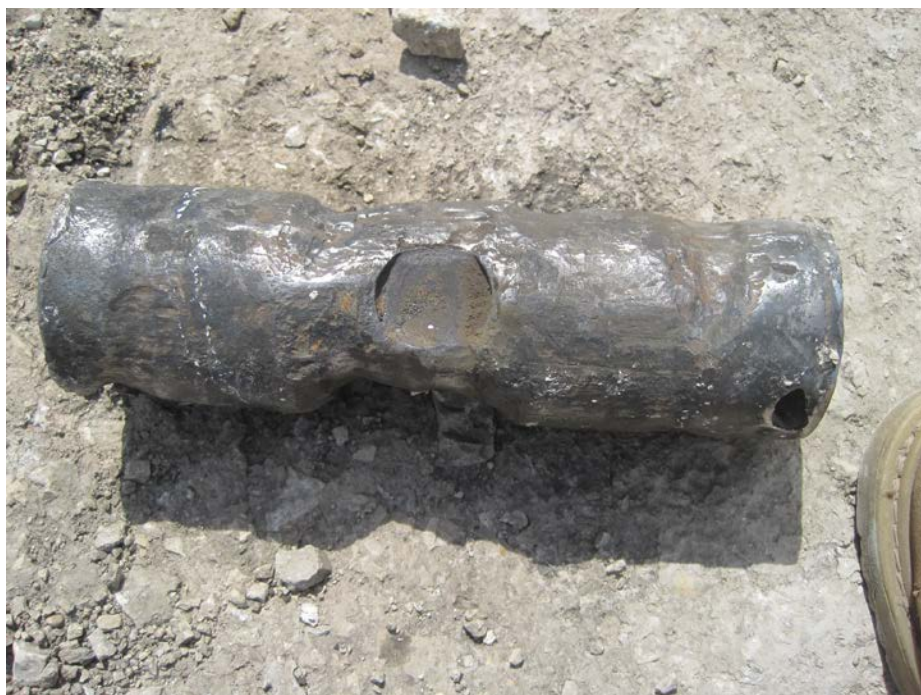
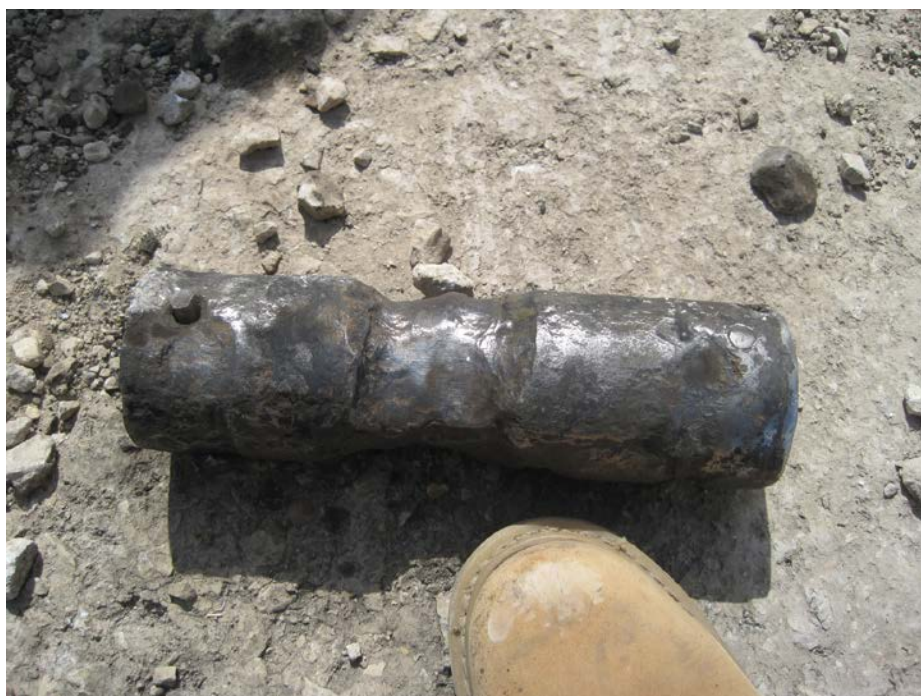
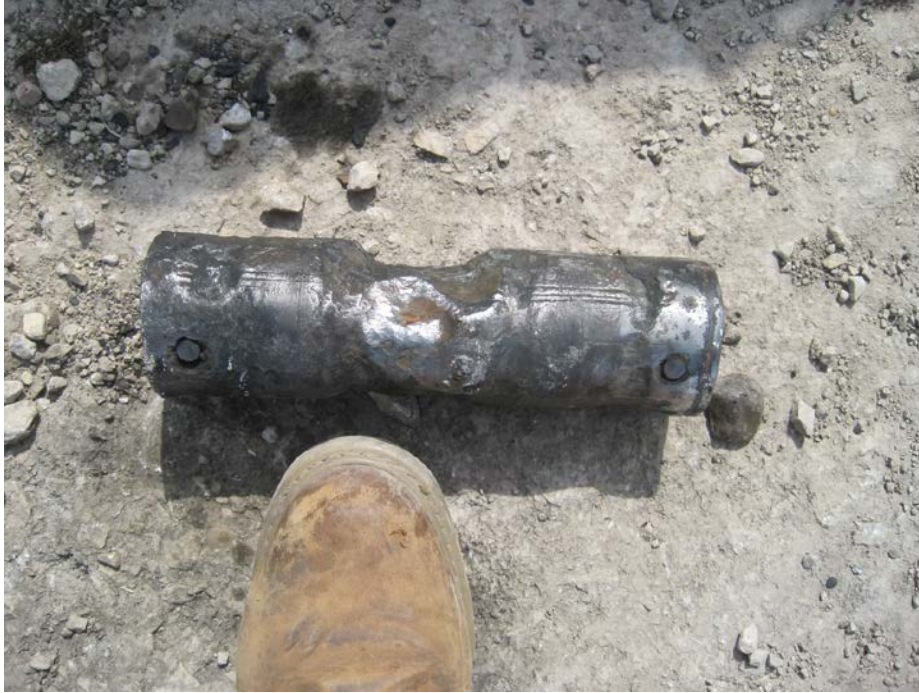
- The hinge pin is the most degraded of the three components of the hinge assembly. The hinge pin has lost approximately one-third to one-half of its cross-sectional area. The section loss is not uniform around the circumference of the pin. It is not apparent if the section loss is a result of corrosion alone or a combination of corrosion and wear. See Figure 5-16 to Figure 5-19.

It is our engineering opinion that for the hinge assembly inspected; the castings are probably suitable for continued use, the hinge plates are highly questionable for continued use, and the hinge

pin is unacceptable for continued use. As a failure of any one of the critical components can result in a failure of the entire hinge assembly, all three critical components must be suitable for continued use of the hinge assembly. As the condition of the pin is unacceptable and the condition of the hinge plates is questionable, the inspected hinge assembly is not acceptable for continued use.
