PLACID (TP-4) SPILLGATE NO. 2 INSPECTION REPORT

BLACK & VEATCH PROJECT NO. 406598

Guadalupe-Blanco River Authority

27 OCTOBER 2021

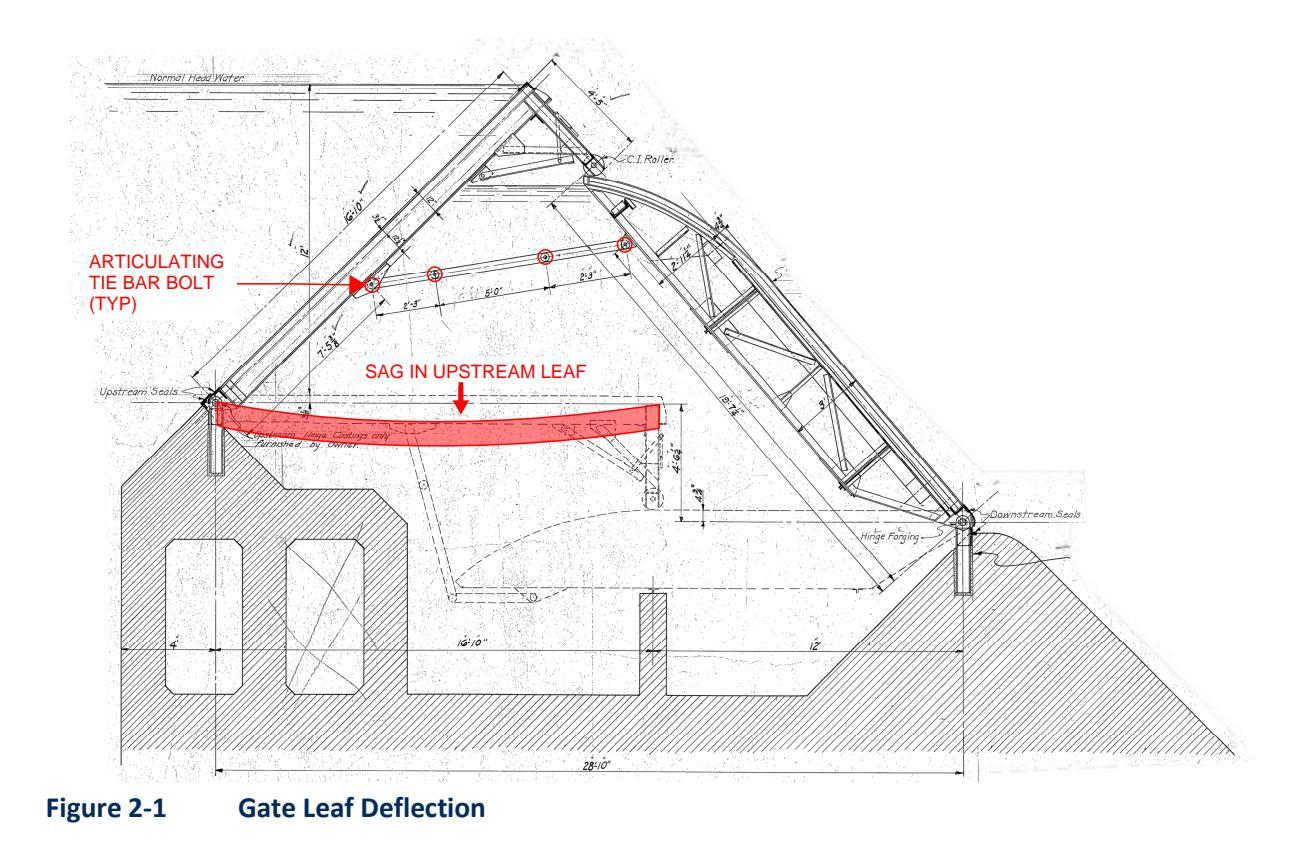
During inspection, it was noted the north end of the Gate 2 upstream leaf showed a significant deflection over several beams spanning between the hinge and the crest point of the gate, Figure 2-1 and Figure 6-6. This area was visibly holding water. Additional observations were as follows:

- Based on survey information taken during the inspection, the 2nd through 5th beams from the middle pier all had deflection of greater than 1" in the middle of the span with the 3rd beam having deflection of 2.16", Figure 3-3. The gate was in the down position with no load thus the deflection observed is permanent.

The north end of Gate 2 has a significant deflection in the upstream leaf. At least four of the beams show deflection without any load being applied; thus, indicating these beams were loaded past the yield point and are now permanently deformed. Normal water loading would not have caused this type of deformation and the load required to cause such deflection is on the order of five times normal maximum water pressure. It is unknown if this was due to debris impact load or another stress condition that may have occurred during previous gate operation.

Repair of the structural members that are permanently deflected would be a complex effort. First, even under minimum flow conditions, water still passes over the gates and therefore some means would be necessary to isolate the gate area to complete the repairs. Replacement of the steel members would also require reinstallation of all the timbers that span between the beams and resealing these. The condition of these timbers is unknown and replacement could identify the need for additional replacements or modifications. The location of the gate in the downward position presents significant access challenges to the inside of the gate to make repairs. Additionally, the

timing of preparing, procuring materials, and making any such repairs would likely roughly coincide with the timing for which the formal replacement project would begin anyway. Therefore, temporary repairs would not be prudent.

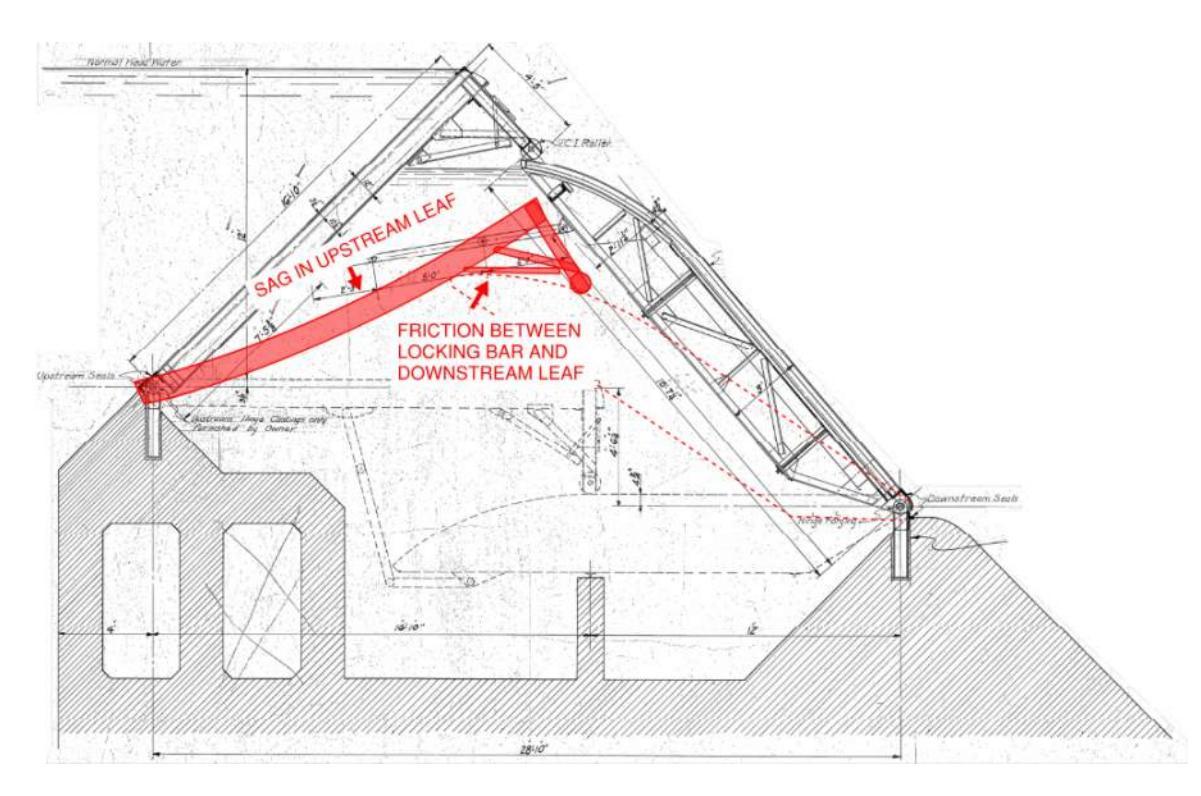
- The underside of the locking bars located on the upstream leaf of Gate 2 showed significant rubbing indicating these are contacting the curved beams on the downstream gate leaf during gate travel. These locking bars were replaced in 2018 and thus the damage is relatively recent. The observed damage included at a minimum missing paint but also grooving/gouging beginning to occur, Figure 6-8. All the locking bars showed some level of contact with those on the north end showing the most gouging. This friction would be a prime indicator for additional and unintended forces on the gate. This is also a possible cause for the gate getting stuck during the recent operation of attempting to lower the gate. It is apparent the gate leaves are making contact.

- The observed deflection is likely partially affecting the contact between the two leaves of the gate, at least on the north end, Figure 2-2.
- In 2018 a survey was conducted inside of the gates while in the fully raised position. The CAD file of the survey points was provided to Black & Veatch for evaluation. Strategic points were surveyed from the underside of the gates including the hinge positions and bolt locations on the articulating tie bar that connects the two leaves, Figure 2-1. From the available data, there was an observable inward deflection at the bolt connection location on the upstream leaf for several beams in the same location as noted above with the most prevalent being specifically on the 3rd beam with approximately ½" of deflection. Similarly, the downstream leaf had outward deflection in the same location.

Figure 2-2 Gate Contact Between Locking Bar and Downstream Leaf in Upward Position

The gate is binding during travel as noted by Operations staff and as physically observed by the scraping and gouging of the locking bars on the upstream leaf contacting the curved section of the downstream leaf. The scraping is observed on all the locking bars, however, is more apparent near the areas where the gate is deflected. Thus, it is apparent the deflection is contributing to the binding during travel.

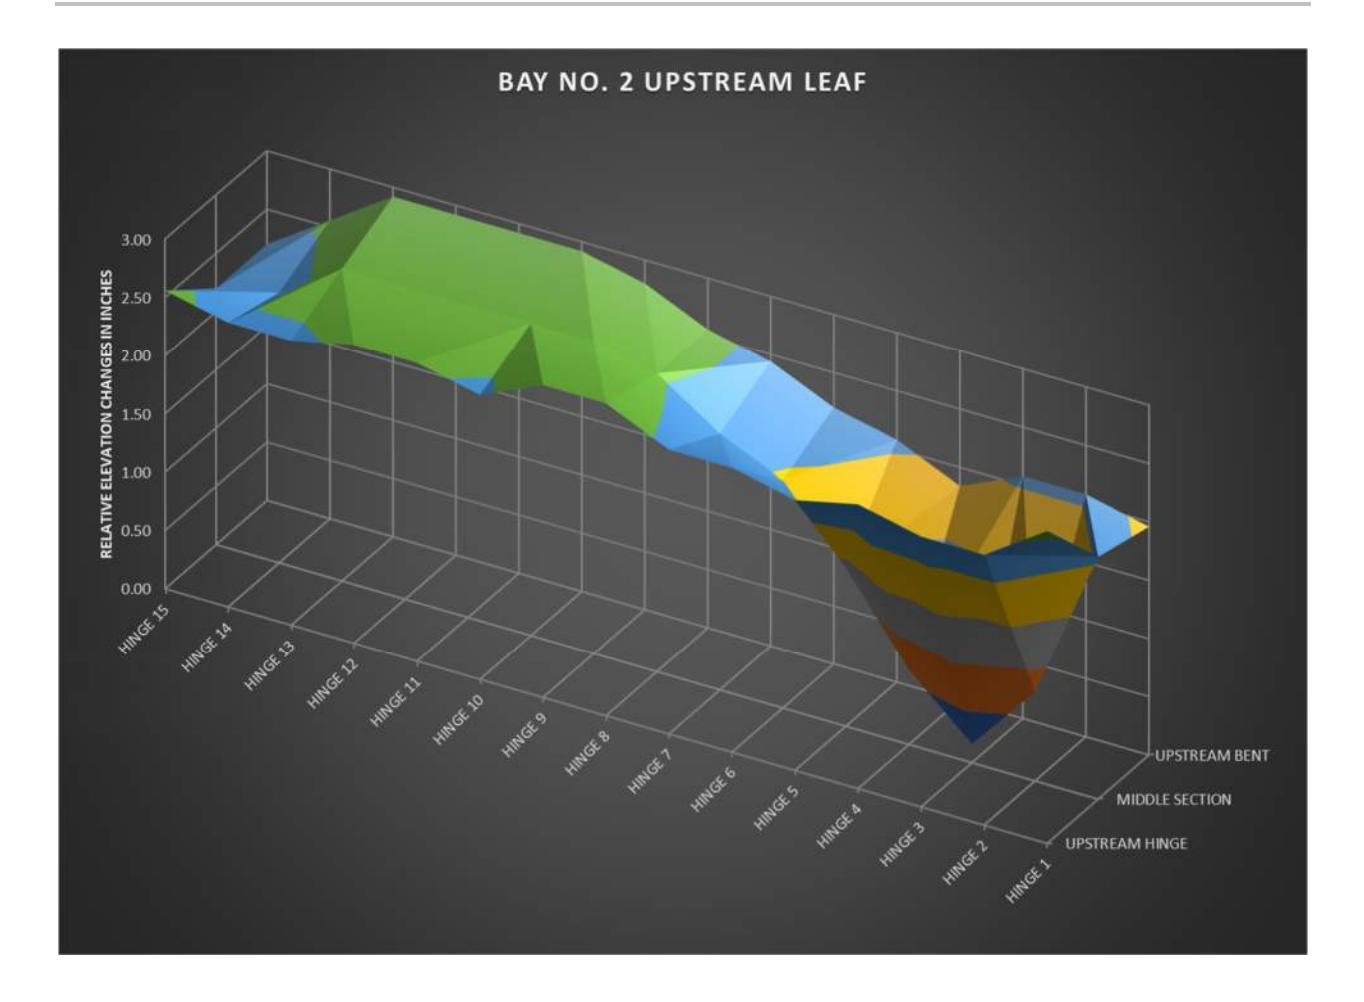
Figure 3-3 Gate No. 2 Upstream Leaf Relative Elevation

- Significant deflection of the Gate 2 upstream leaf structural beams near the north end as noted previously in this report, Figure 3-3.
- Gate 2 upstream leaf at the crest has a high point in the middle about 1" more than each of the north and south ends, Figure 3-3.
- Gate 1 upstream leaf at the crest sags about 1" from the south to the north end, Figure 3-4.

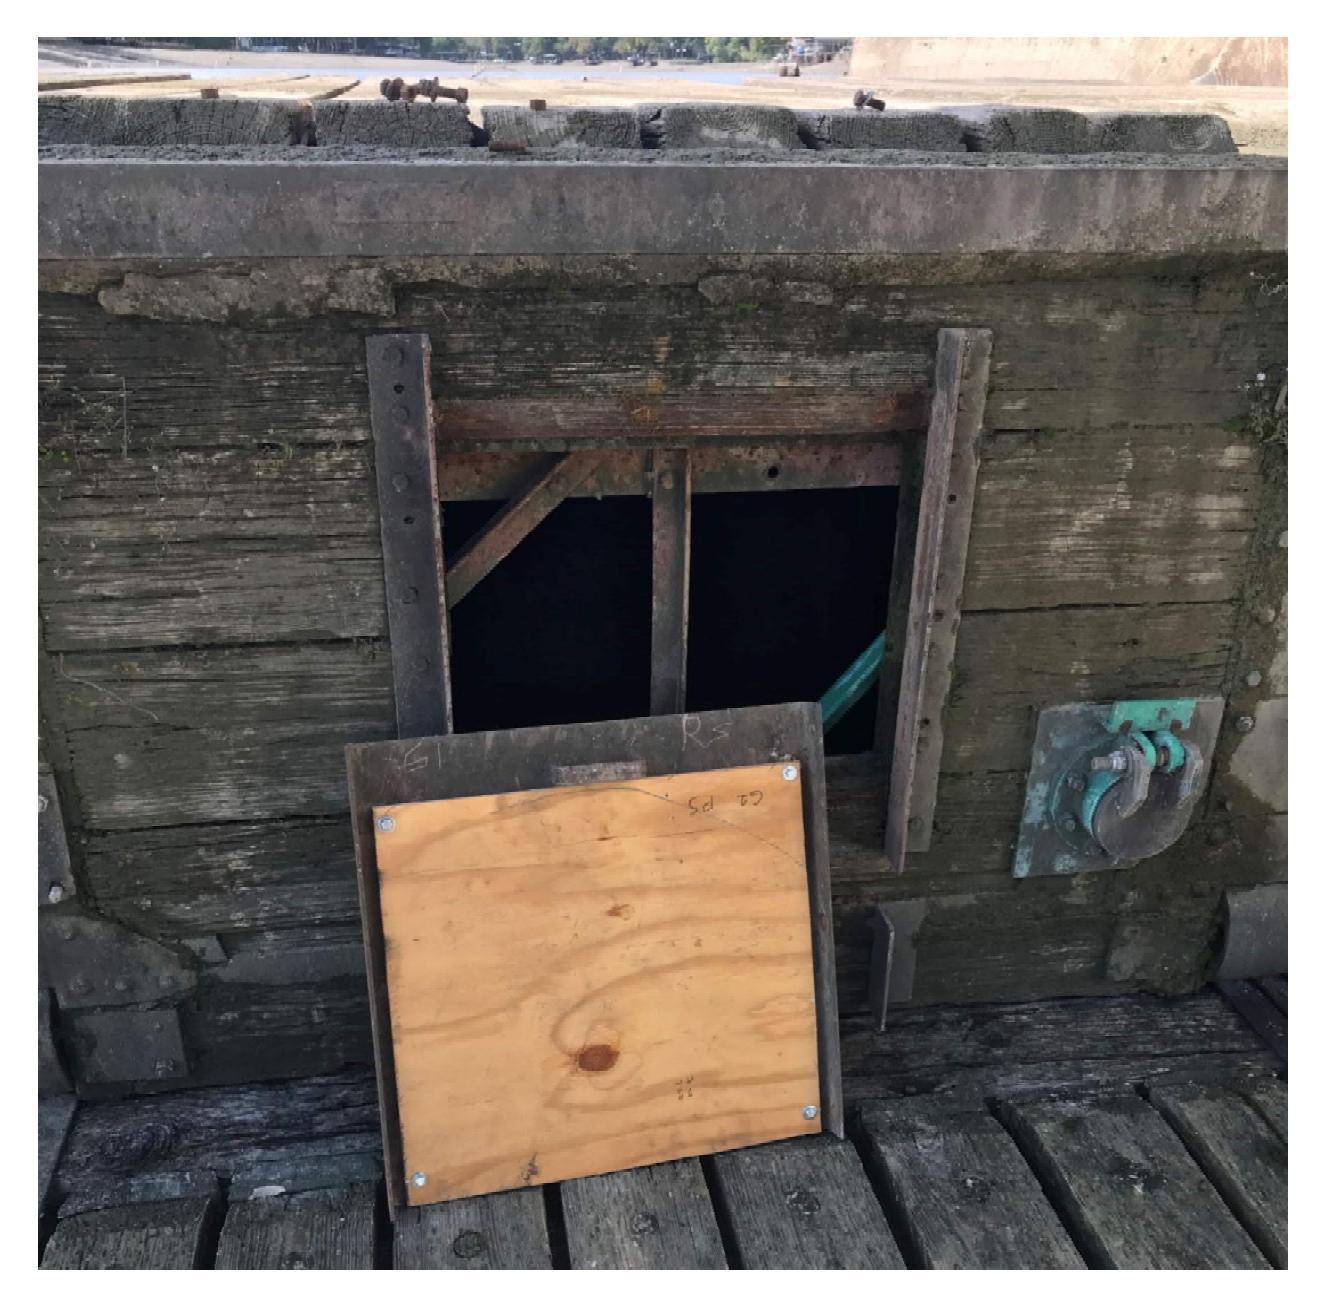
It was observed that the hatch covers on the vertical leg of the upstream leaf of Gate 2 were missing, Figure 6-2. Additionally, one of the air operated gate vents was stuck in the open position. For the gate to raise, the water flow into the gate from the buoyancy chamber must be greater than any leakage through the gate. With these large openings passing flow this is likely the main reason operation of the gate was limited to only a few feet as water was escaping through these openings. Replacement of the covers would significantly improve buoyancy.

The main cause of leakage which prevented the gate from rising appears to have been the missing hatch covers on the upstream leaf. The replacement of these hatches would likely reduce the majority of the leakage. During the inspection there was no attempt made to raise the gate to observe other leakage locations. However, it was noted that the seal conditions and gaps were notably better than the recently inspected H-4 gate. The main challenge if further leakage improvements were necessary is that typically these repairs would be done with the gate in the up position. It's unknown if these repairs have ever been done with a gate in the down position. With the gate in the down position there is little room in which to work below the gate. Because of the limited access for repairing a gate in the down position there could be much uncertainty in the estimated cost and schedule required to complete the repairs if it is determined such repairs are required.

Figure 6-2 Gate Leaf Access Hatches Missing

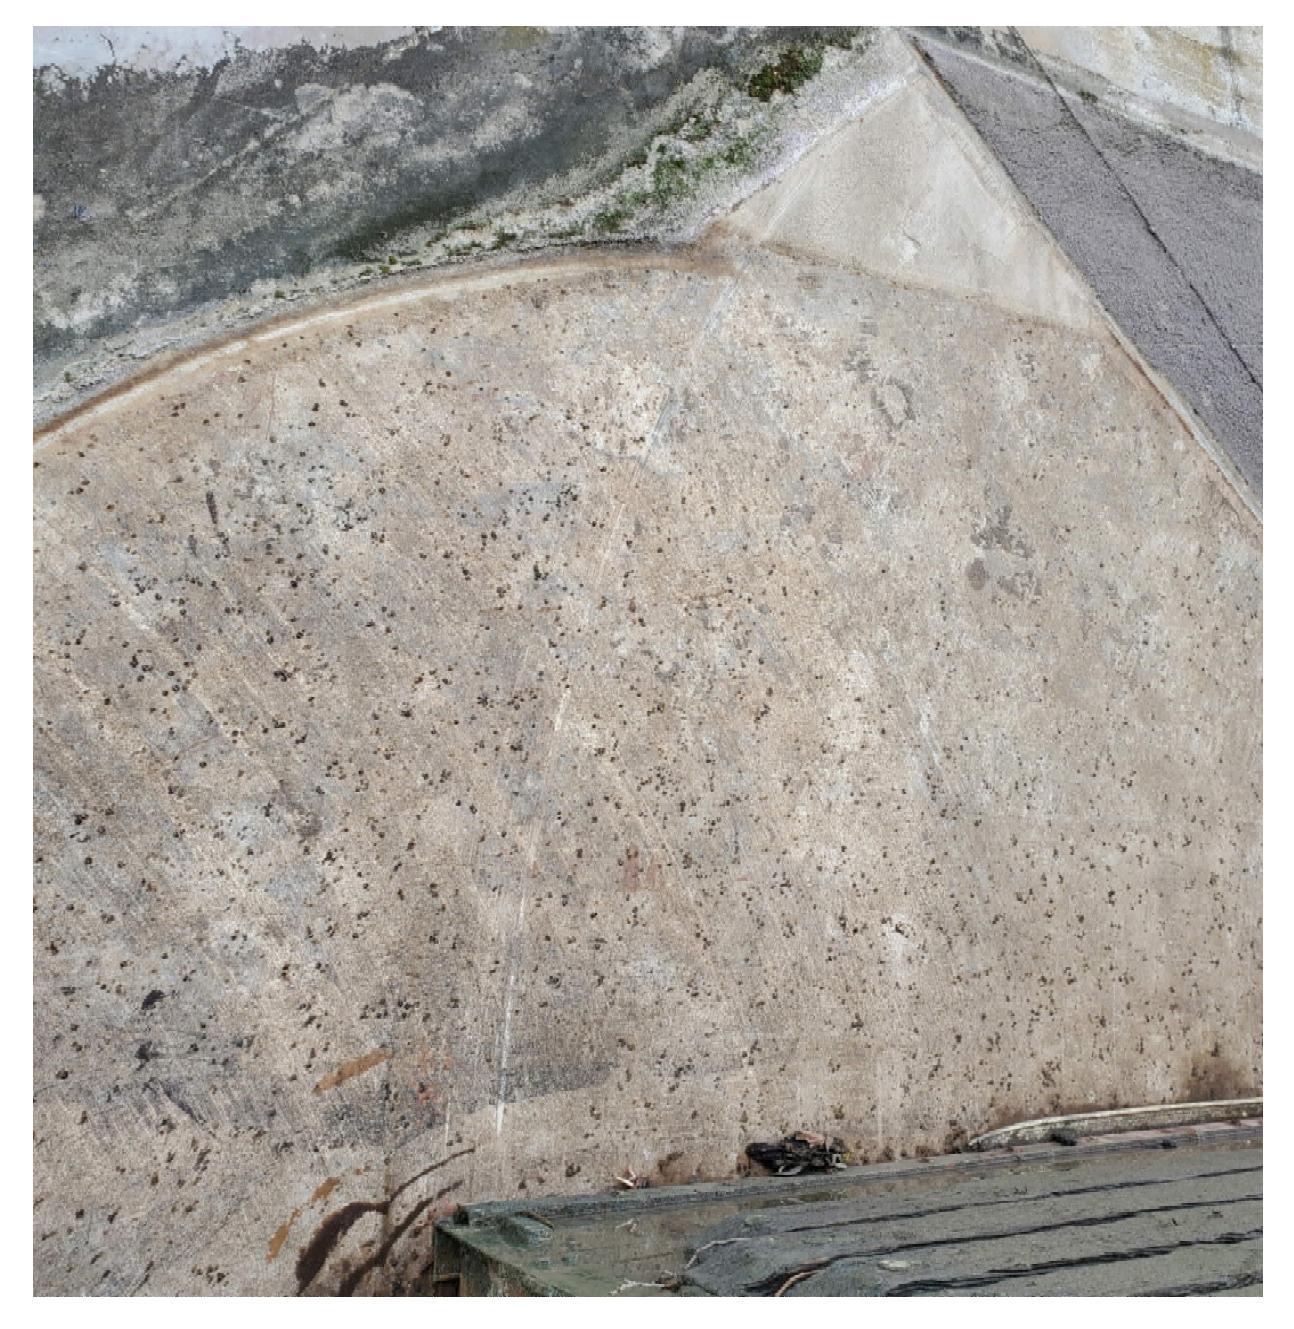
- Both concrete structures on either side of Gate 2 show recent rubbing of the upstream leaf during gate rotation, Figure 6-3 and Figure 6-4. Rubbing on the powerhouse wall side was more significant and would account for the missing seal at this location. The gouging into the wall is relatively minimal and less than that observed on the recent failed gate at H-4. There was no observable rubbing of Gate 1 on the walls.

Figure 6-3 Gate 2 Powerhouse Wall (South) Upstream Leaf Wall Rubbing & Missing Side Seal

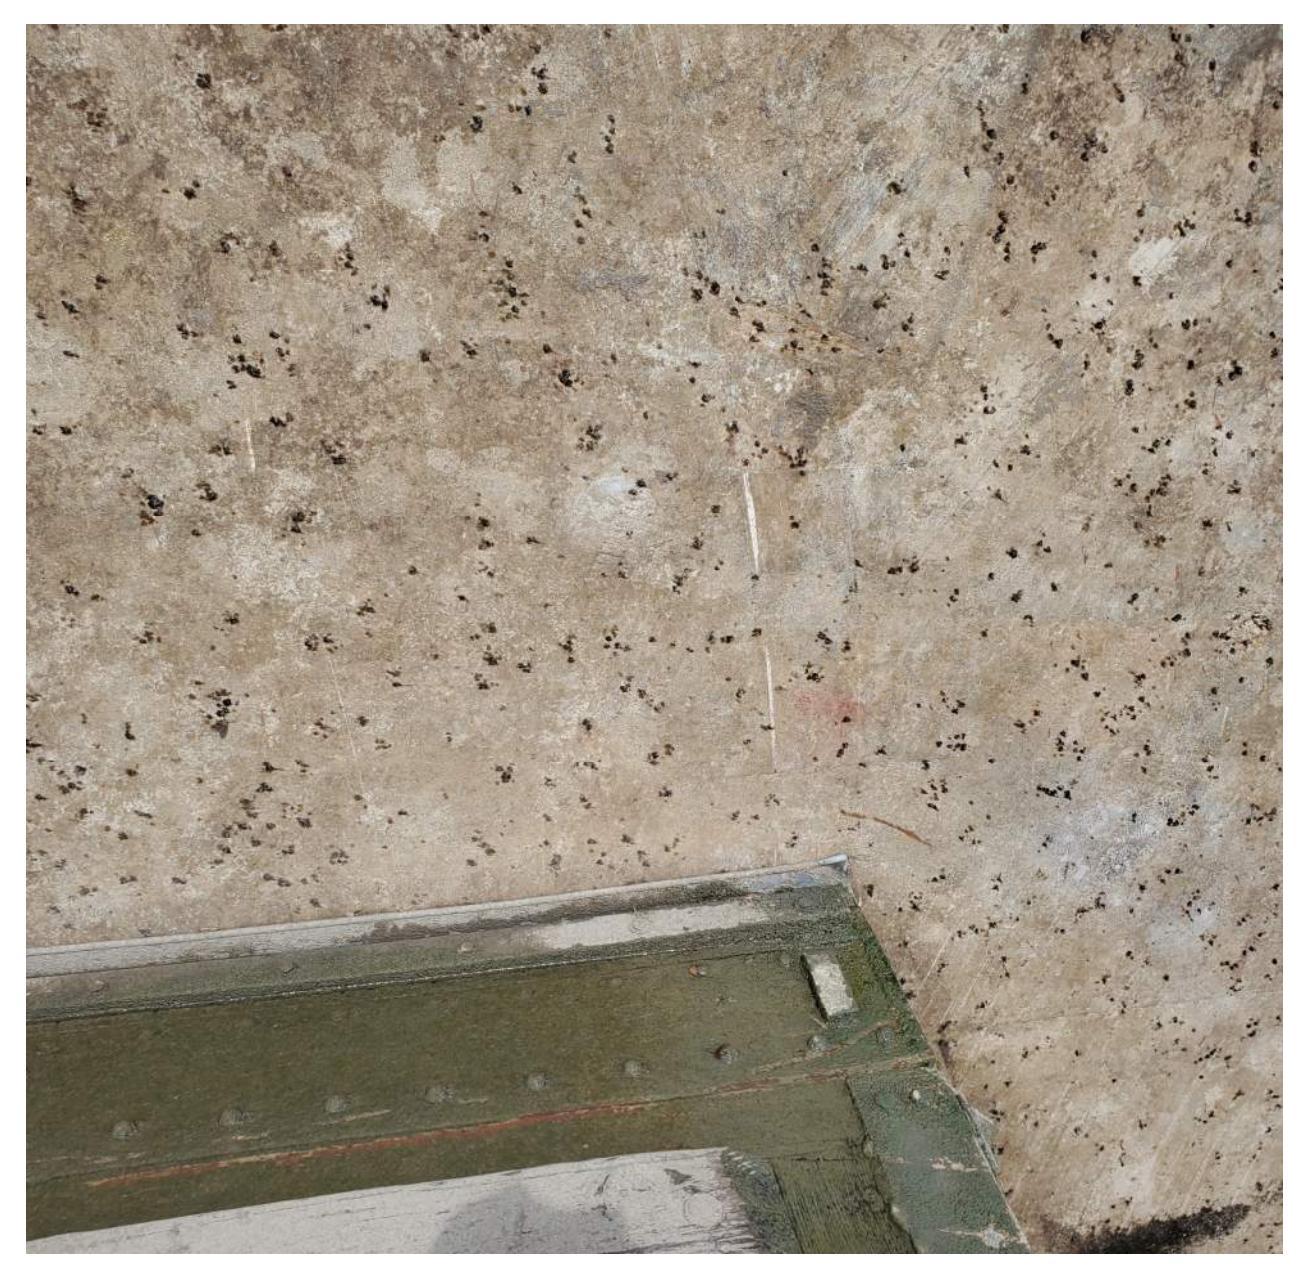
Figure 6-4 Gate 2 Upper Leaf Middle Pier (North) Wall Rubbing

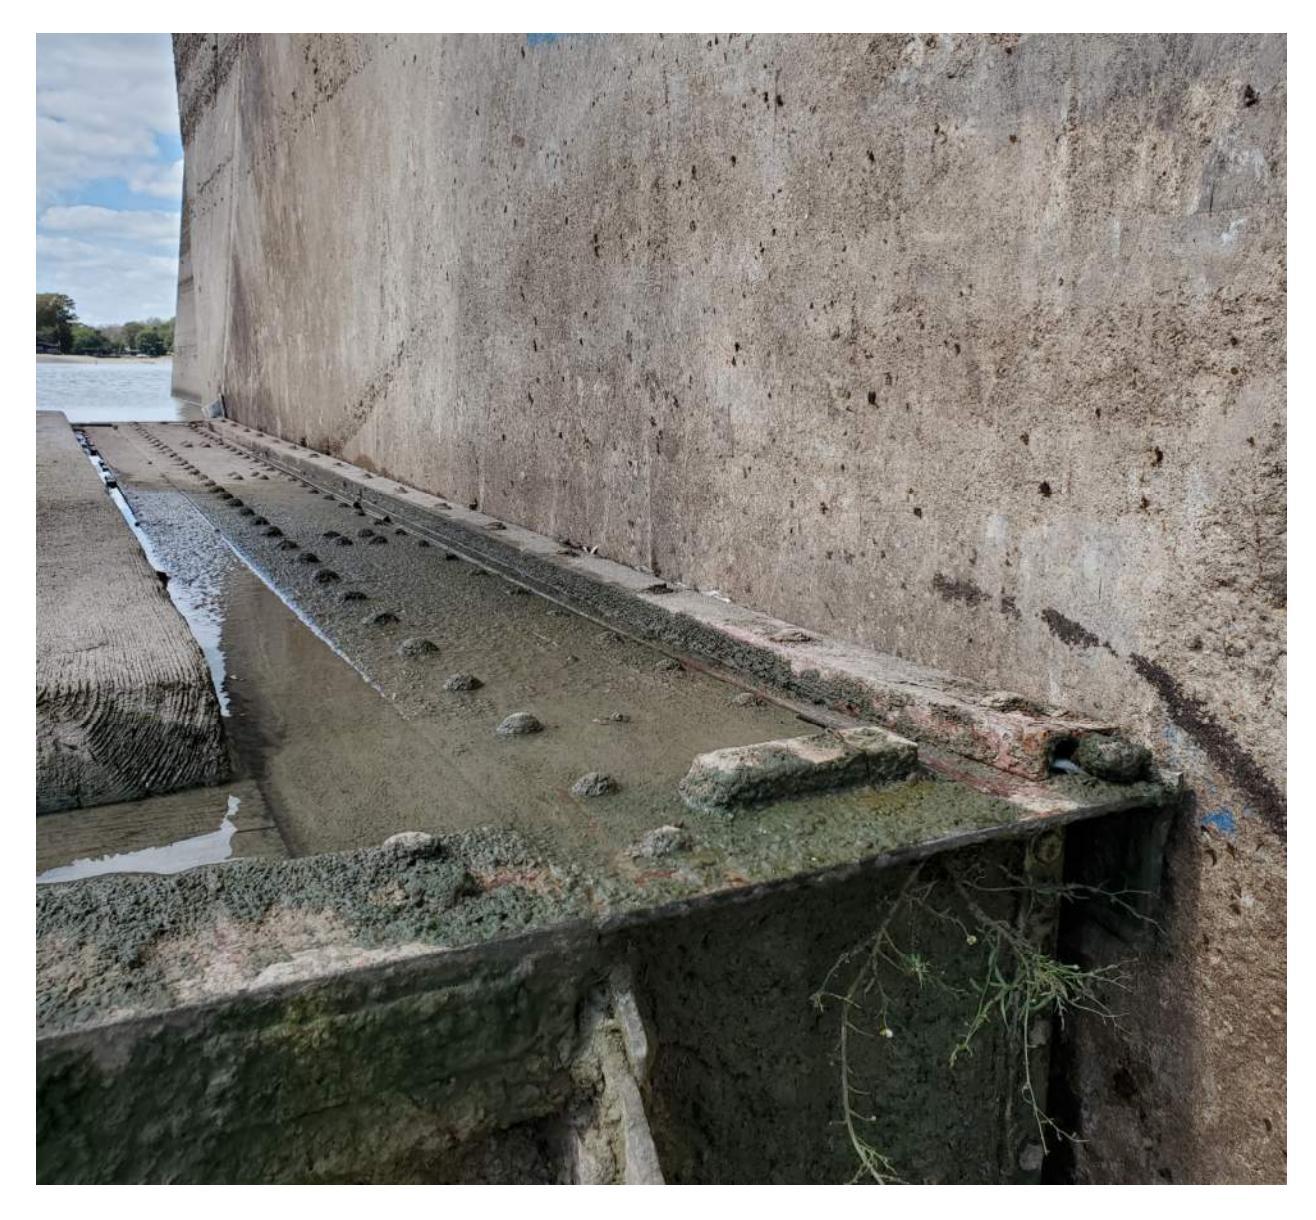
Figure 6-5 Gate 1 Upper Leaf Abutment Wall (North) Missing Seal But No Rubbing

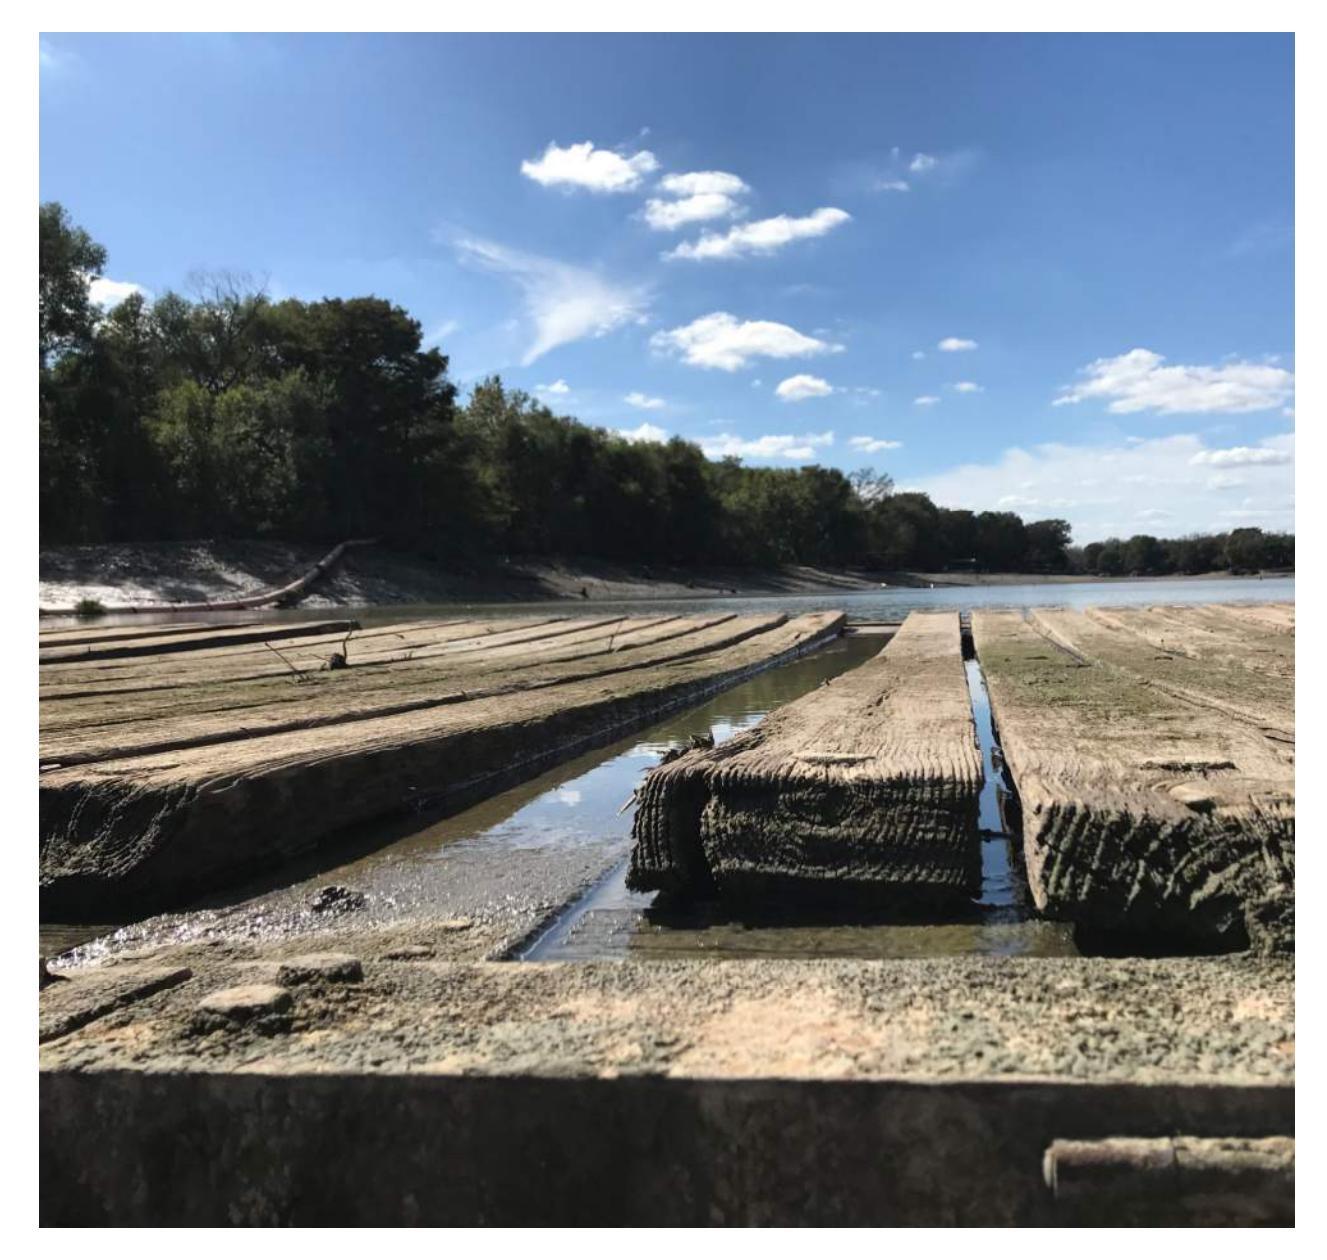
Figure 6-6 Gate 2 Upstream Leaf Deflection (North end)

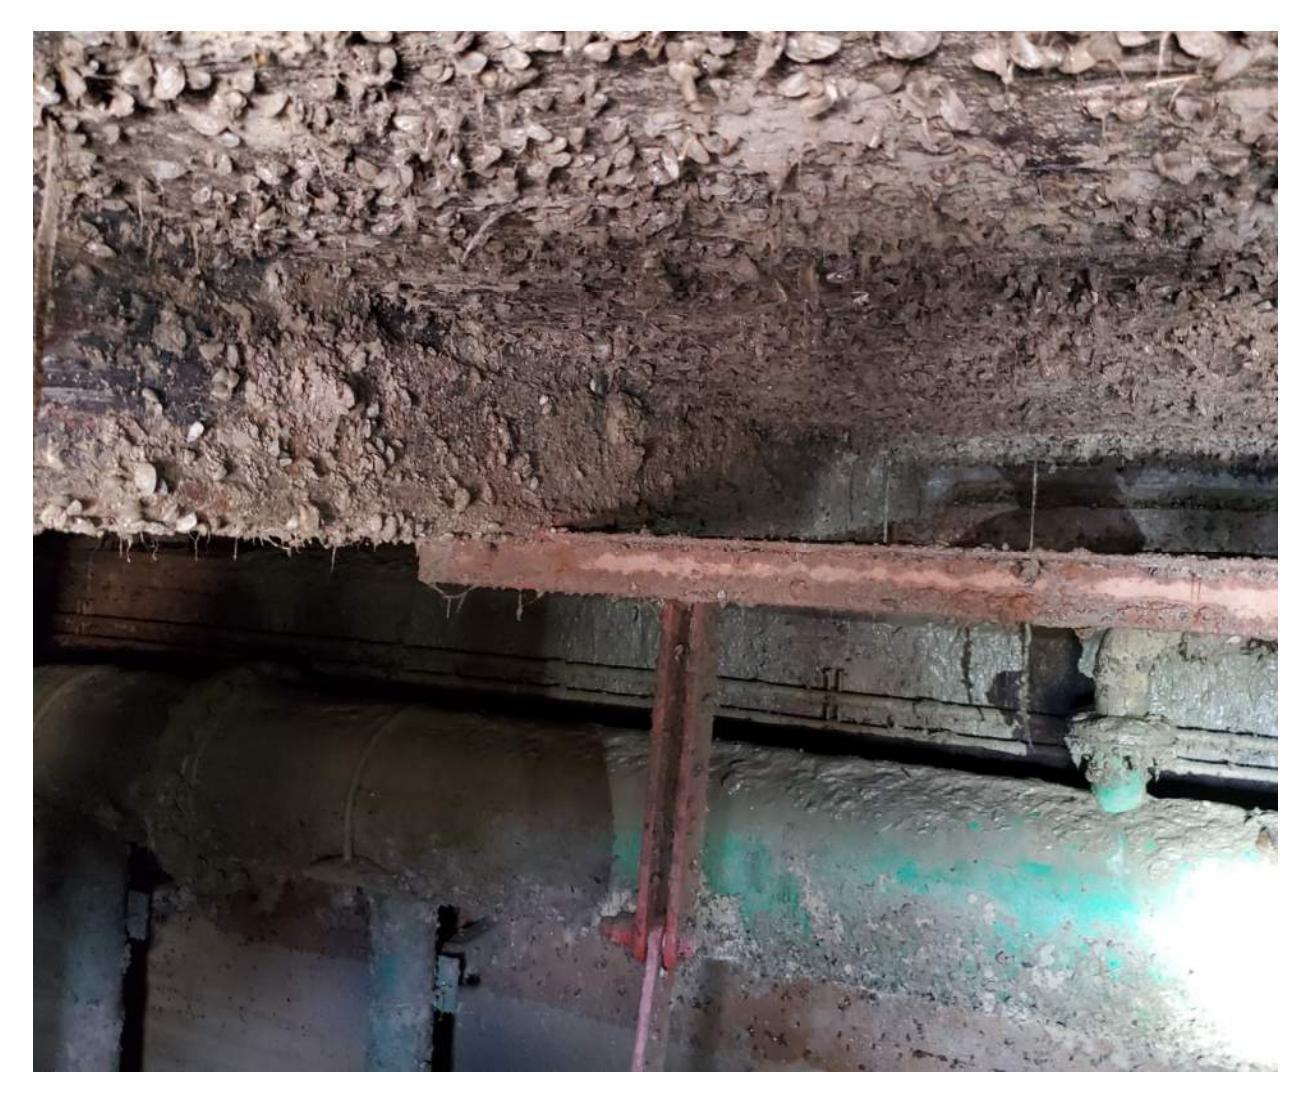
- One of the timbers that spans between beams on the north end was visibly lower by an estimated 1-2 inches than the rest of the timbers as viewed from the underside of the gate. This beam was in the middle of the span between the hinge and the crest. It is unknown if the timber is permanently damaged or just significantly deflected but is an apparent weak point in the structure.

Figure 6-7 Gate 2 Upstream Leaf Underside

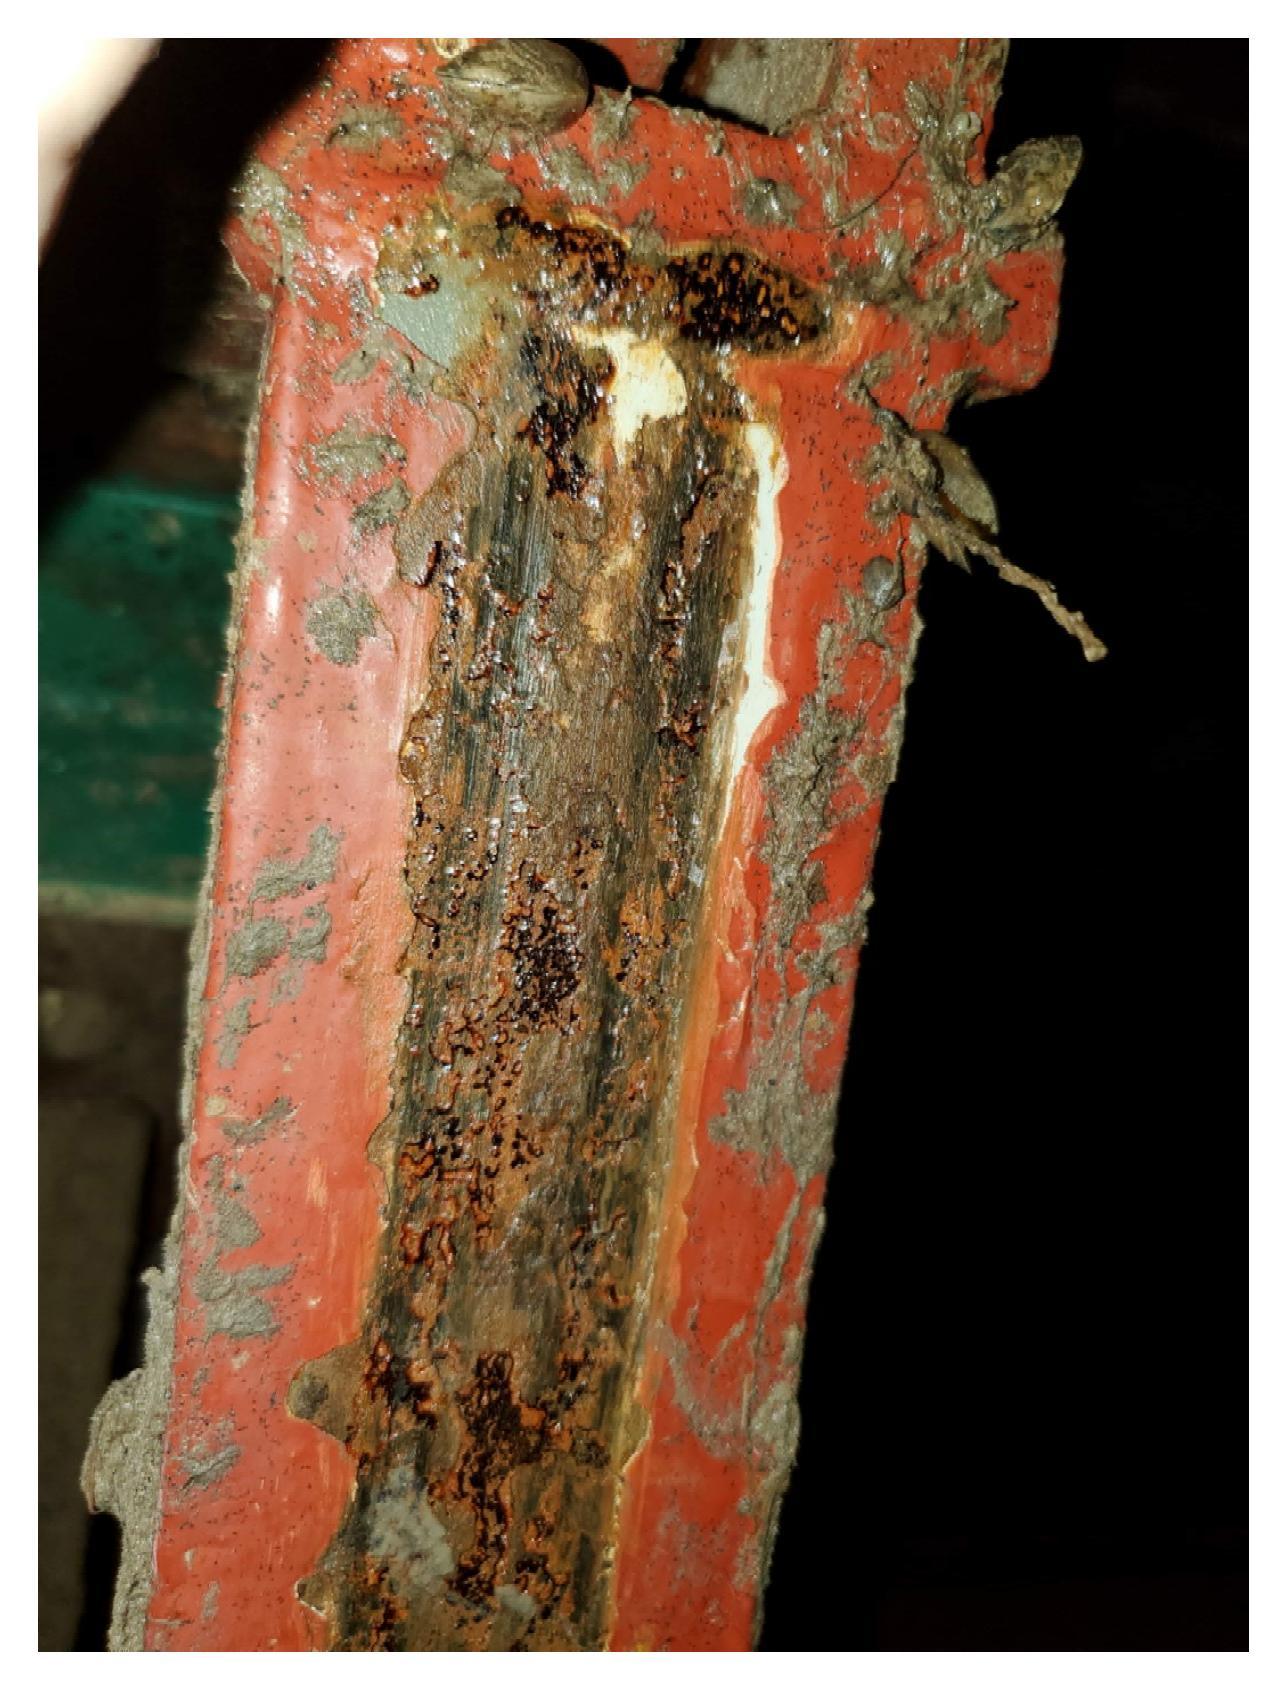
Figure 6-8 Gate 2 Locking Bar Contact Gouging
