DUNLAP SPILLGATE HINGE INSPECTION REPORT

BLACK & VEATCH PROJECT NO. 400368

Guadalupe-Blanco River Authority

13 AUGUST 2019

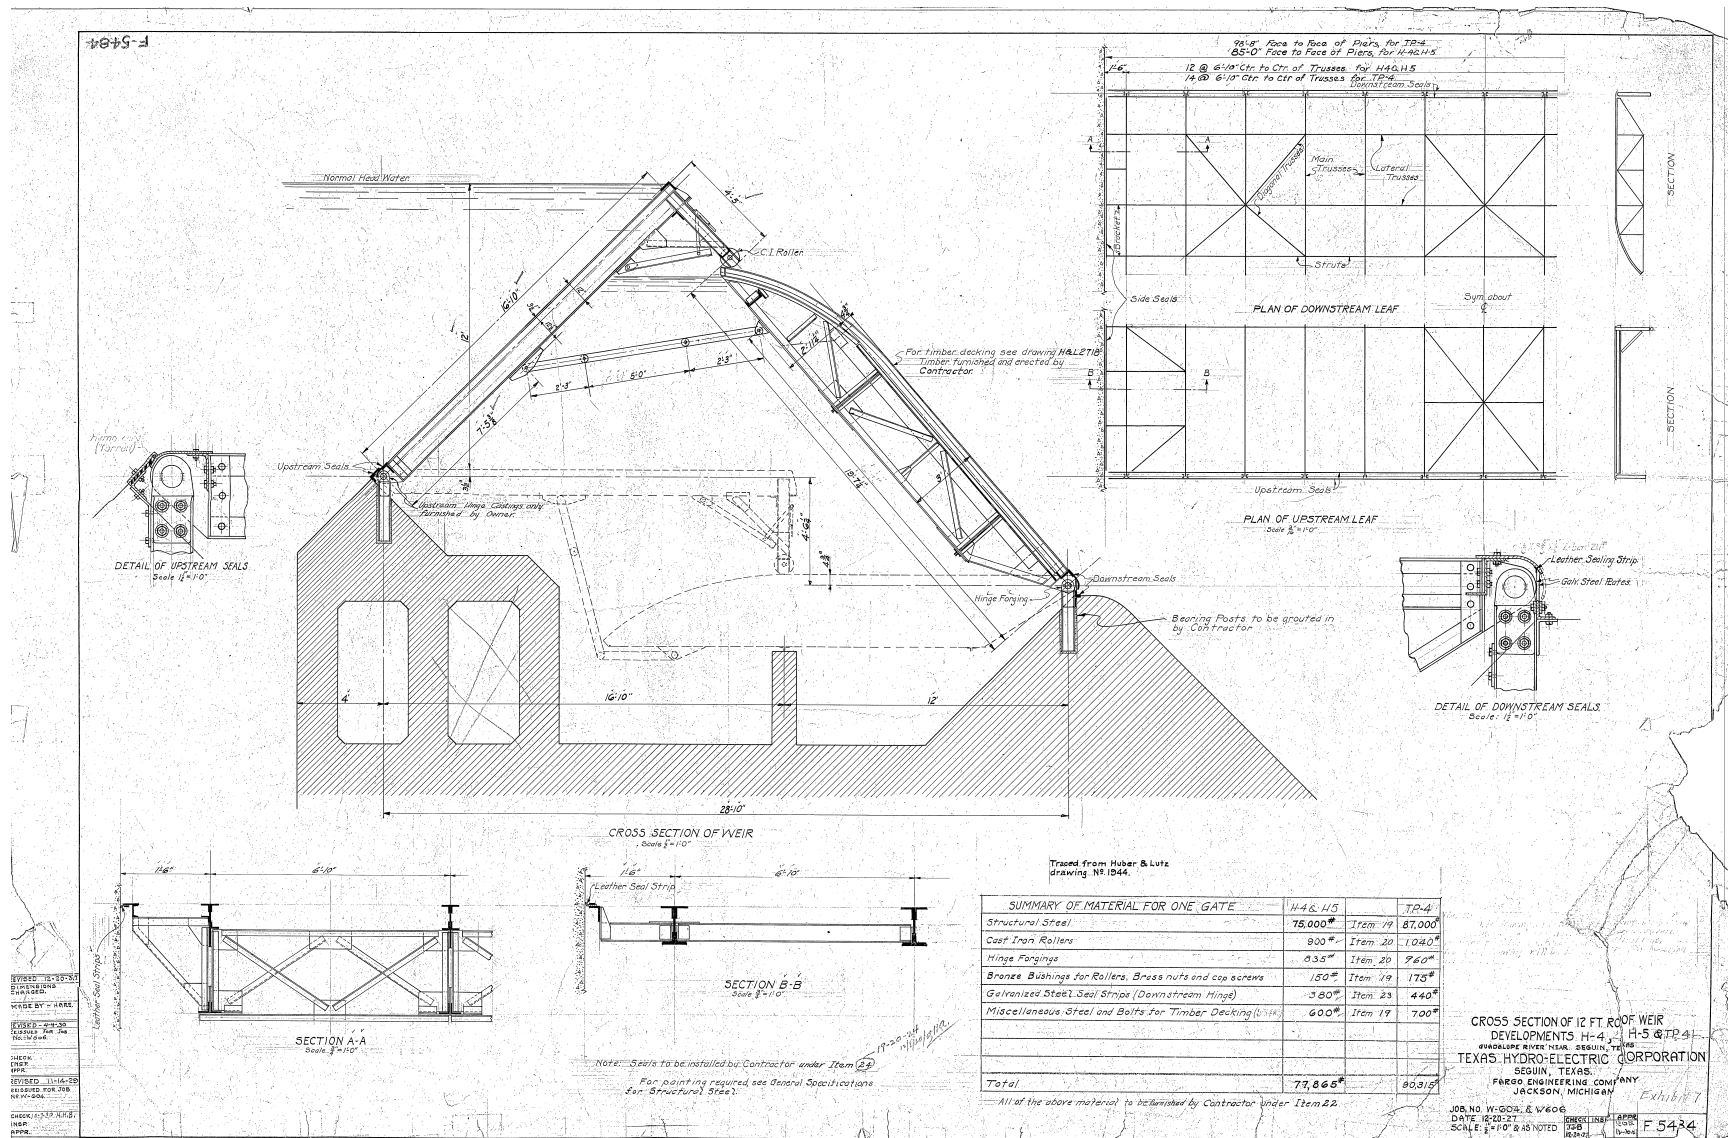
Figure 5-20 Gate Sectional Drawing

The major components of each hinge assembly include the castings which are anchored to the concrete spillway, the hinge plates which are anchored to the gate truss, and the pin which connects the castings to the hinge plates. A failure of any one of these three components could result in a catastrophic failure of the gate. See original construction drawings Figure 5-20 and Figure 5-21 which presents the typical cross section of the gate assembly and hinge connection.
